NASA TN D-1158

STRUCTURAL DYNAMIC EXPERIENCES OF THE X-15 AIRPLANE

TECHNICAL NOTE D-1158

STRUCTURAL DYNAMIC EXPERIENCES OF THE X-15 AIRPLANE*

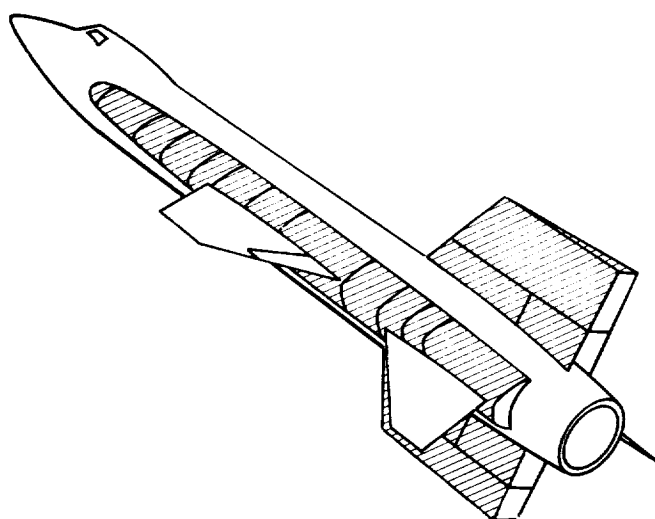
Figure 8

Panel flutter, on the other hand, has occurred in flight and has required modification of extensive areas of the fuselage side fairing and vertical tails which are shown as shaded areas in figure 8. The side-fairing panels consisted of a series of flat rectangular panels stiffened by a corrugated inner skin with the corrugations oriented normal to the flow. This orientation was chosen to allow thermal buckling and thus minimize thermal stresses, but of course it is not desirable from a panel-flutter standpoint. With respect to the vertical tail, the skin panels were unsupported over a length of about 60 inches

with a rib spacing of about 6 inches. This resulted in long narrow panels having length-width ratios of about 10.

Panel flutter of the fuselage side-fairing panels was experienced early in the flight program, however, and resulted in a severe vibration felt throughout the airplane. Strain gages were installed on the side-fairing panels, and panel flutter was detected at dynamic pressures as low as 650 lb/sq ft and identified as the source of vibration. Wind-tunnel tests on a full-scale side-fairing panel were initiated in the Langley Unitary Plan wind tunnel. During these tests, the panel flutter that was measured was in good agreement with the flight measurements. At the completion of these tests, cracks were found which originated at drain holes in the corrugations and extended outward to the base of the corrugation. Inspection of the airplane revealed several panels which had similar fatigue cracks. Previous wind-tunnel and analytical studies had indicated that a simple modification would be effective in preventing panel flutter on this type of panel. The modification, shown in figure 9, consisted of a hat-section stiffener riveted to the corrugations and extending in the streamwise direction. This modification was installed on the test specimen and tested in the Langley Unitary Plan wind tunnel. These tests served to clear the airplane for flight up to dynamic pressures of 2,000 lb/sq ft. Proof tests were later conducted in the Langley 9- by 6-foot thermal structures tunnel under conditions of aerodynamic heating at dynamic pressures up to 3,250 lb/sq ft and cleared the airplane for flight to dynamic pressures of 2,500 lb/sq ft. A total of 38 side-fairing panels, ranging in size from 12 by 15 inches to 23 by 34 inches, were stiffened in this manner on each X-15 airplane for panel flutter.

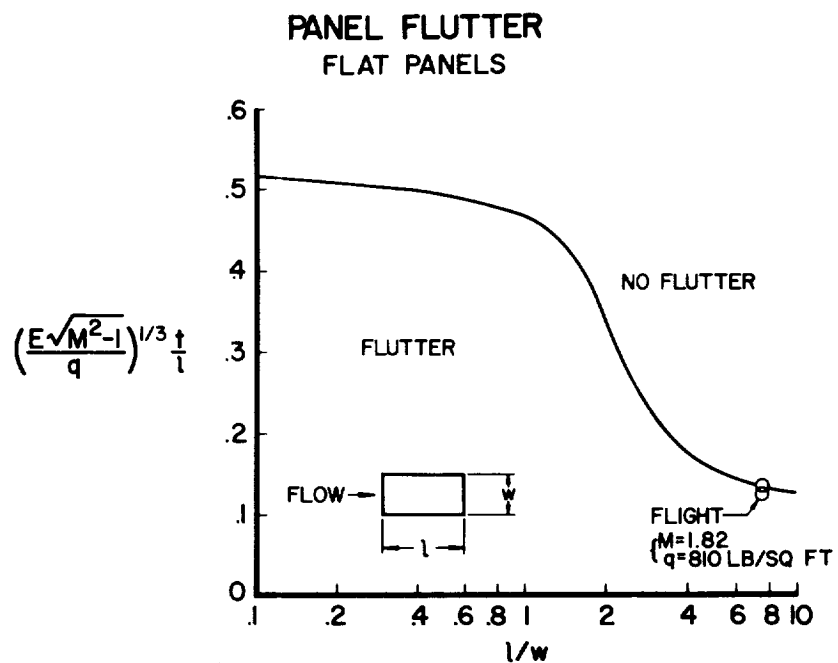
Figure 10

Results of these and other investigations have led to the establishment of the panel-flutter envelope, reproduced from reference 1, shown

in figure 10. In this figure the flutter parameter $\left(\frac{E \sqrt{M^2 - 1}}{q} \right)^{1/3} \frac{t}{l}$ is plotted as a function of length-width ratio l/w . The area under the curve is the flutter region and the area above the curve is free of flutter. The results of panel-flutter measurements in flight made on the flat rectangular panels on the vertical tail of the X-15 airplane are also shown in the figure. It is interesting to note the agreement between the flight data and the previously established envelope.

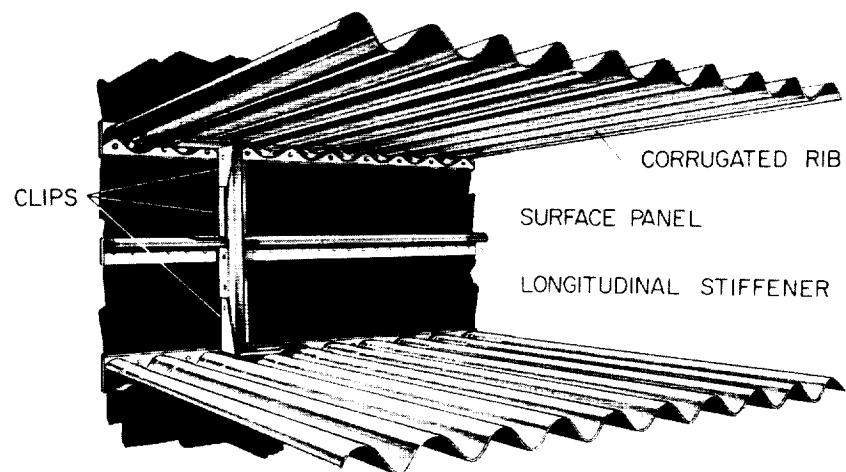
Figure 11

Panel flutter of the vertical tail also became of concern during proof tests to clear the airplane for classical flutter. Consequently, a second series of tests on the vertical stabilizer was planned to investigate panel flutter. Tests were made in the Ames 9- by 7-foot tunnel at a Mach number of 1.7 and dynamic pressures up to 1,300 lb/sq ft. Flutter was obtained on the skin panels with a length-width ratio of 10 and also on the closure rib. As a result of these tests, the affected panels were stiffened by North American Aviation, Inc., and flights with the stiffened stabilizer were restricted to dynamic pressures no greater than 1,500 lb/sq ft at Mach numbers up to 3.0.

The modifications made to the vertical tail for panel flutter are shown in figure 11. The modification consists of J-section stiffeners riveted longitudinally on the inner surface of the skin at the centerline of the panel. In addition, lateral stiffeners were riveted to the skin near the panel centers and tied into the longitudinal stiffeners. Tests have shown that lateral stiffeners are ineffective in preventing flutter unless they are firmly restrained against rotation about the line of attachment to the panel. Other areas of the vertical tail in which panel flutter was experienced were on the corrugation-stiffened panels, similar to the side-fairing panels. The modification consisted of a single, light-weight hat section riveted to the backs of the corrugations along the longitudinal centerline. Proof tests were made on a full-scale ventral incorporating all modifications for panel flutter. These tests were made at a Mach number of 3.0, a dynamic pressure of 3,250 lb/sq ft, and a stagnation temperature of 660° F, with no evidence of flutter.
